# A Four-Dimensional Historical Building Defect Information Modeling (HBDIM) Framework Integrating Digital Documentation and Nanomaterial Consolidation for Sustainable Stucco Conservation

This study proposes a four-dimensional Historical Building Defect Information Modeling (HBDIM) framework designed to support the documentation, diagnosis, and conservation of deteriorated historic stucco elements. The framework integrates multi-source digital documentation techniques, including terrestrial laser scanning (TLS), high-resolution photogrammetry, and automated total station measurements with laboratory-based material diagnostics to create a unified digital environment for defect detection and conservation assessment. The approach was applied to the Baron Empain Palace in Egypt as a representative case study of complex architectural heritage affected by material deterioration. Within the HBDIM workflow, point cloud processing and defect-oriented information modeling were used to identify and spatially localize deterioration features such as cracking, erosion, and material loss. Laboratory investigations—including computed tomography (CT), scanning electron microscopy (SEM), transmissi

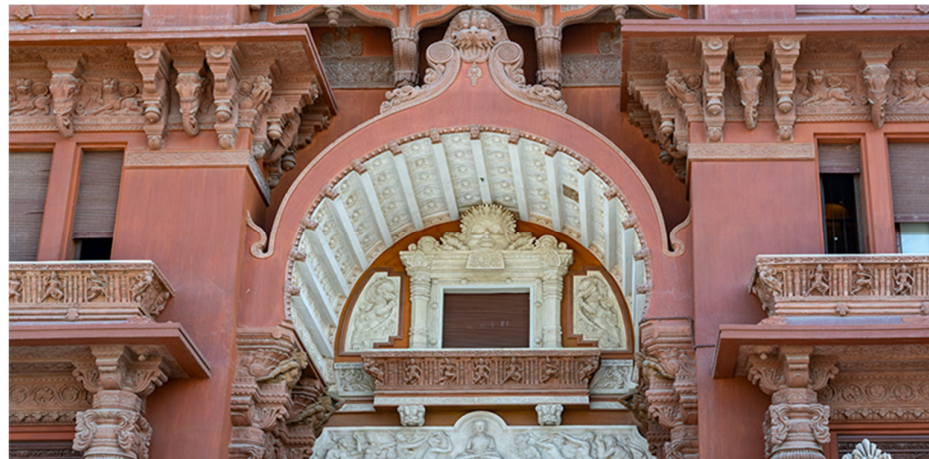
**Figure 2.** Plaster implementation technology in Baron Palace [30].

The Baron Palace utilized stucco formations as decorative elements in both art and construction, representing one of the most important design features that provided a distinctive tone to the entire structure. These elements were usually crafted beforehand and subsequently transferred for installation. The processes and factors of stucco formation deterioration include relative humidity, air pollution, temperature variation, and wind erosion; there were also physicochemical and mechanical factors that caused weathering of stucco formations [25–29].

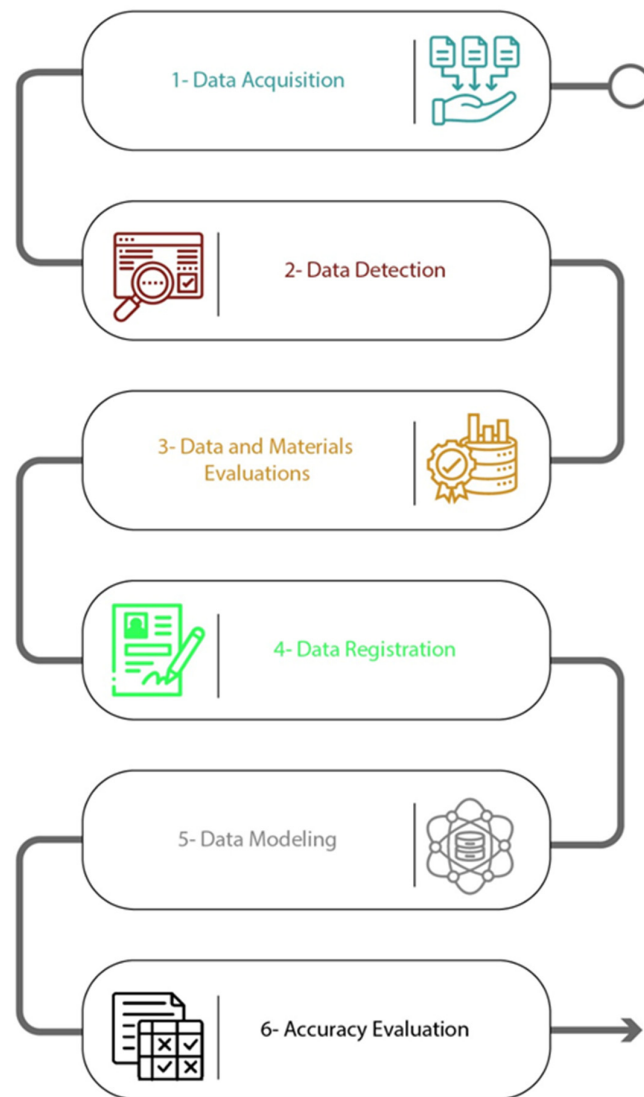
**Figure 3.** The methodology steps.

The work system and the activities are as follows, as shown in (Figure 3).

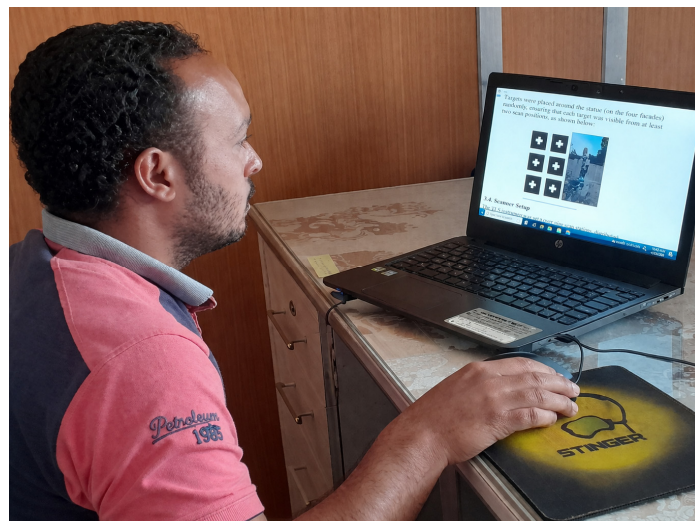
**Figure 8.** 3D modeling programs with laptop computer.

Data processing and modeling were conducted using a high-performance laptop computer, as shown in (Figure 8), equipped with professional 3D modeling and point cloud processing software. The primary software packages employed included RiSCAN, Geomagic Studio, and AutoCAD 3D (version 2025), each serving a specific role within the workflow. RiSCAN (version 2.23), was used for scan registration, visualization, and preliminary point cloud management, while Geomagic Studio (version 12.0) supported noise filtering, outlier detection, meshing, and surface reconstruction. AutoCAD 3D was used for geometric referencing, dimensional verification, and integration of modeled elements. This software combination enabled efficient handling of large datasets and accurate implementation of the Defected Information Modeling (DIM) process.

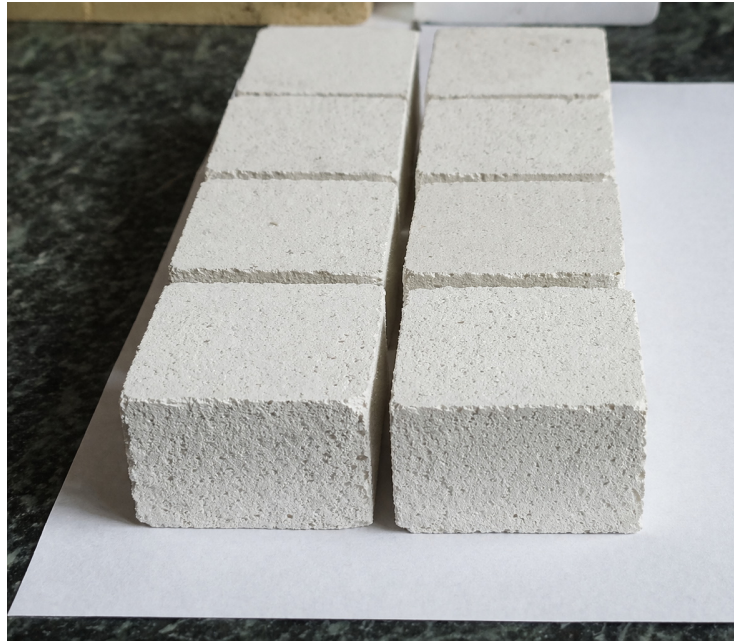
Figure 10. Showing stucco formation sample.

Stucco formation samples representative of the original historic material were prepared for laboratory analysis by cutting them into cubic specimens measuring  $5 \times 5 \times 5$  cm, in accordance with standard mechanical testing requirements. Separate sets of samples were prepared for microstructural investigations using scanning electron microscopy (SEM) to examine morphological characteristics before and after consolidation treatment. Prior to treatment, all samples were dried in a convection oven at  $110^\circ\text{C}$  for 24 h to achieve constant weight and eliminate residual moisture, thereby ensuring consistent initial conditions across all specimens. This preparation procedure minimized variability related to moisture content and enhanced the reliability and comparability of both mechanical and microstructural analyses, as shown in (Figures 10 and 11).

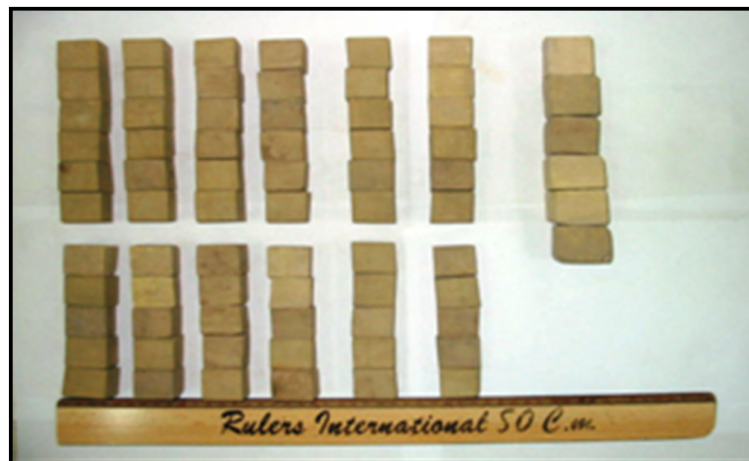
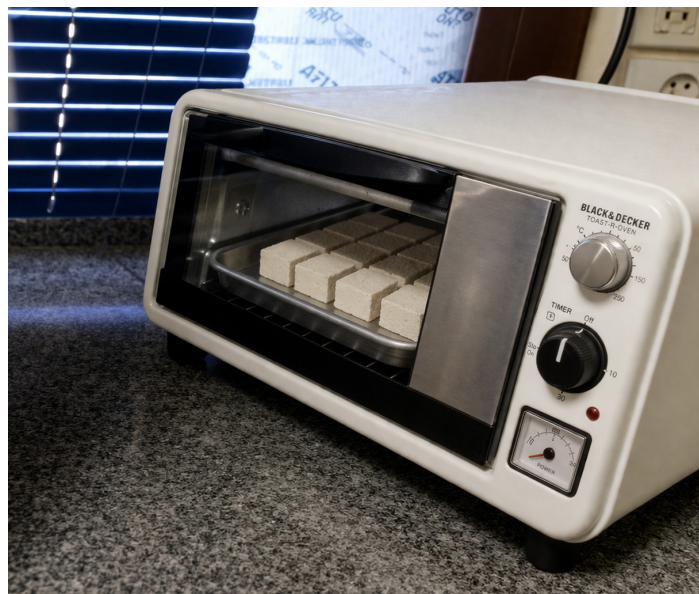
Figure 11. Showing the samples prepared for treatment.

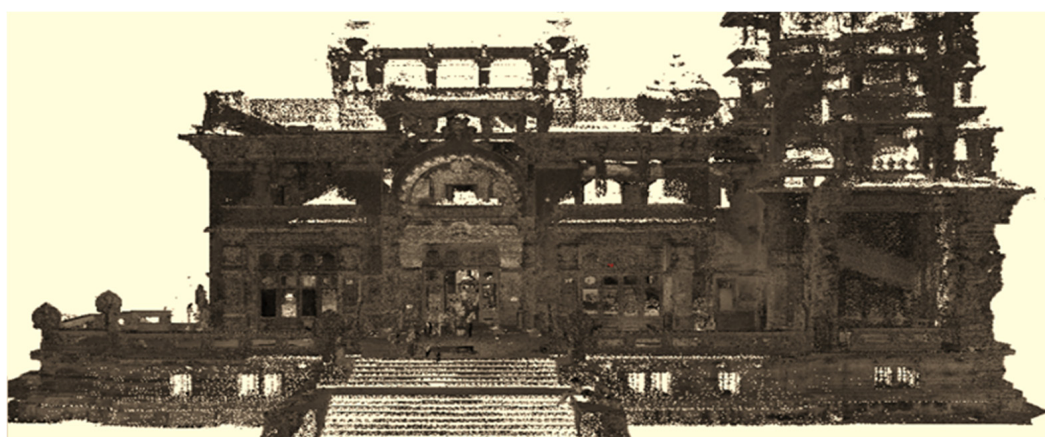
**Figure 20.** Filtration and registration of 23 scans of 12,702,112 points as a real image in RiSCAN.

The data registration process aimed to ensure accurate spatial alignment of multi-scan point cloud datasets acquired from different positions around the Baron Empain Palace and the defective stucco statue. A total of 23 laser scans comprising 12,702,112 points were successfully filtered and registered in RiSCAN, producing a high-resolution and visually coherent representation of the palace geometry (Figure 20). In parallel, the defective statue dataset, consisting of 1,412,194 points, was registered and refined in Geomagic Studio, resulting in a detailed and realistic digital model suitable for defect analysis (Figure 21). The registered point cloud datasets exhibited high geometric fidelity and visual clarity, largely due to the effective utilization of point intensity values during visualization and processing. The ability of both RiSCAN and Geomagic Studio to preserve intensity-based information contributed to enhanced surface detail recognition, which is particularly important for identifying fine-scale deterioration features such as cracks, erosion zones, and material loss. However, the results also revealed practical limitations associated with handling very large point cloud datasets. While higher point densities improved visual resolution, they significantly increased computational complexity, making navigation, manipulation, and real-time interaction more challenging. This observation highlights a critical trade-off between point density and processing efficiency, especially in large-scale heritage documentation projects.

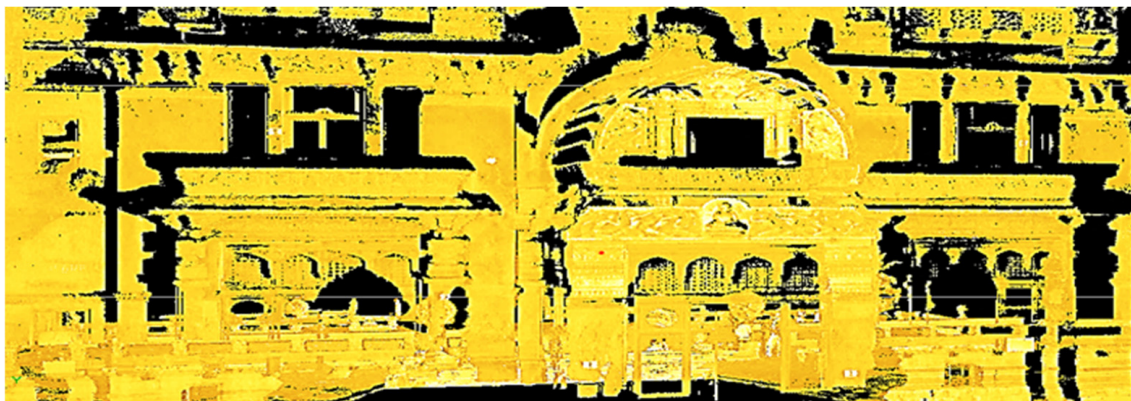
**Figure 24.** (16,297,294) points of 3D laser scan of Baron Palace façade in RiSCAN software.

It starts with acquiring the point clouds of (Z+F) Imager laser scanners from different positions around the Baron Palace and the defective statue to achieve all defective objects, faces, and details. In total, 54,446,410 point clouds of seven registered laser scans of Baron Palace are imported into the modeling software (Geomagic Studio), as shown in Figure 24.
